Town of Huntsville Staff Report

Report Number: OPS-2023-1

Subject: River Mill Park Permanent Washroom Design and Site Preparation Update

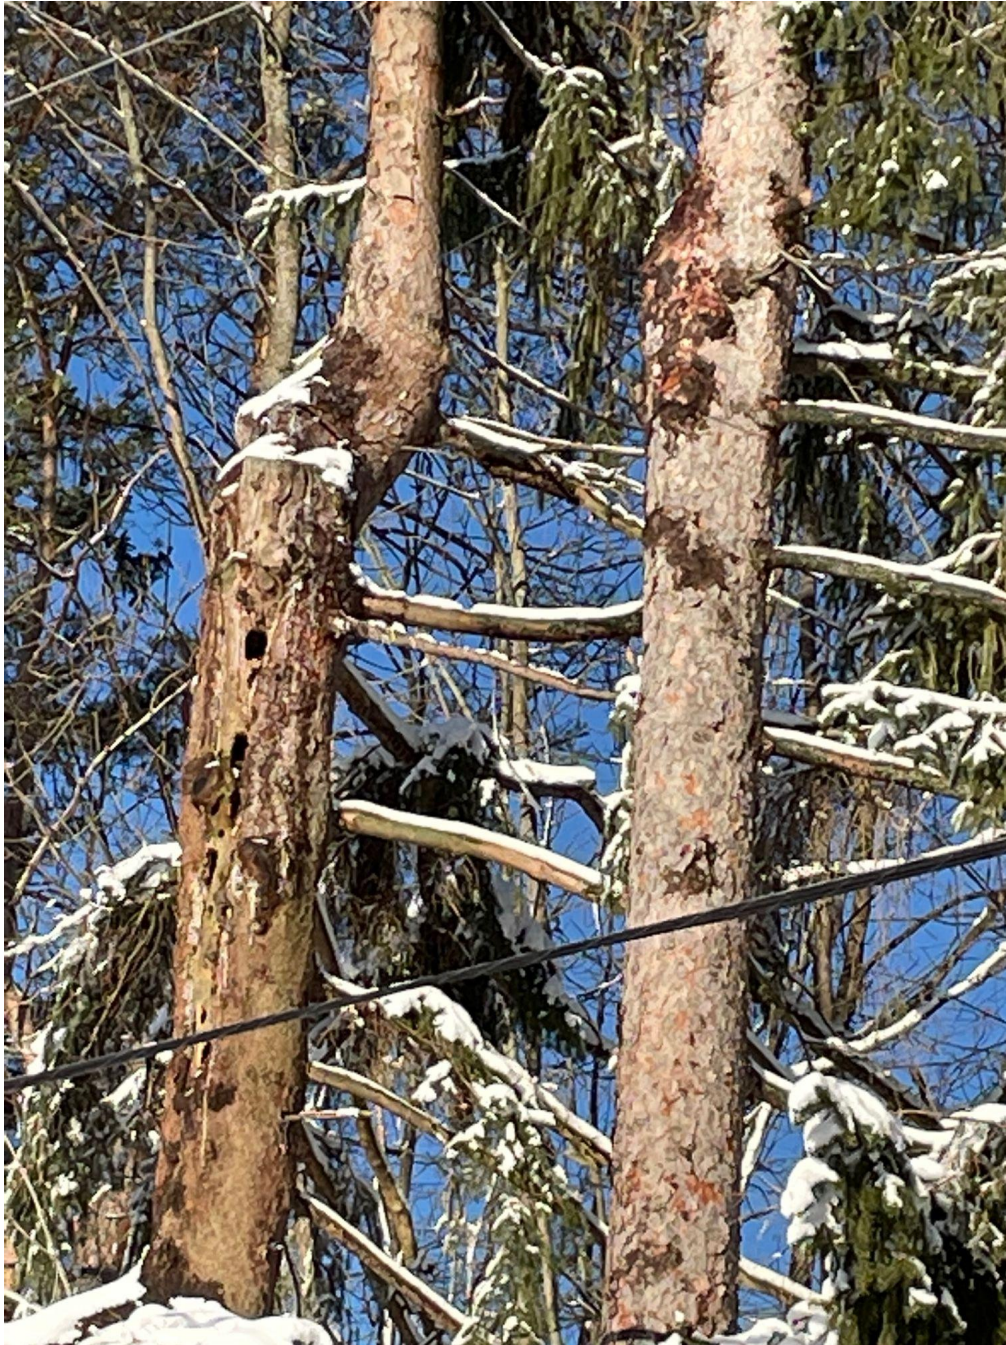
Findings: The row of trees consists of 2 scotch pines (one with no limbs on the trunk), 7 Norway spruce trees (1 with almost no limbs on it) and 1 white pine tree. These trees have an average estimated height of 80 feet with trunk diameters averaging between 16 and 24 inches. These trees were recently pruned to clear the power lines. The pruning removed all of the limbs on the middle 20 feet of the trees on the side towards the wires (see for example picture 3 below). Some pruning removed the entire tops of the trees. This amounted to removal of approximately 25% of the canopy of each tree. Some of the limbs that were removed were major branches over 12 inches in diameter (see picture 2). Previous pruning from many years ago has resulted in large "sucker" growth that is weakly attached to the trees and unbalanced the tree canopies (see picture 3). The overall result of repeated line clearance pruning is that two thirds of the remaining live canopy is in the top third of the tree. Last, several of the trees have visible decay and open cavities in the trunks of the trees (see picture 1).

4. Large cuts, like those in picture 2, are too big to heal. As a result they often lead to decay which can spread into the trunk of the tree. For example, the trunk decay visible in picture 1 is the long term result of past pruning cuts. Not all decay is visible and it is likely that some decay exists in the other trees.

Picture 1: Decay and open cavities in main trunks of trees.

Recommendations: There is no way to mitigate the risks associated with my observations while retaining the trees. More pruning would only make things worse and there's no treatment for decay. Construction would compound tree health problems and increase the likelihood of tree failure. Because trees are tough, they often surprise us and stay standing despite the odds. However, these trees do have numerous risk factors that should be taken seriously. When evaluating tree risk arborists must also consider the likelihood of impacting valuable targets if there was a failure and the consequences of any failure. In this case, the likelihood of impact is high since the trees exist in a park next to a parking area that is usually full of cars and people. Further, any tree failure would certainly impact the power lines and create additional electrical hazards and damage.

When possible tree failure is combined with a high likelihood of impacting a target and the impact would result in significant or severe consequences, I must conclude that these trees present a moderate to high risk level. The building of a new bathroom underneath these trees would increase the likelihood of failure due to root damage and further, the new bathroom would create an additional new potential target. It is my recommendation that these trees be completely removed before building a new structure under their canopies.

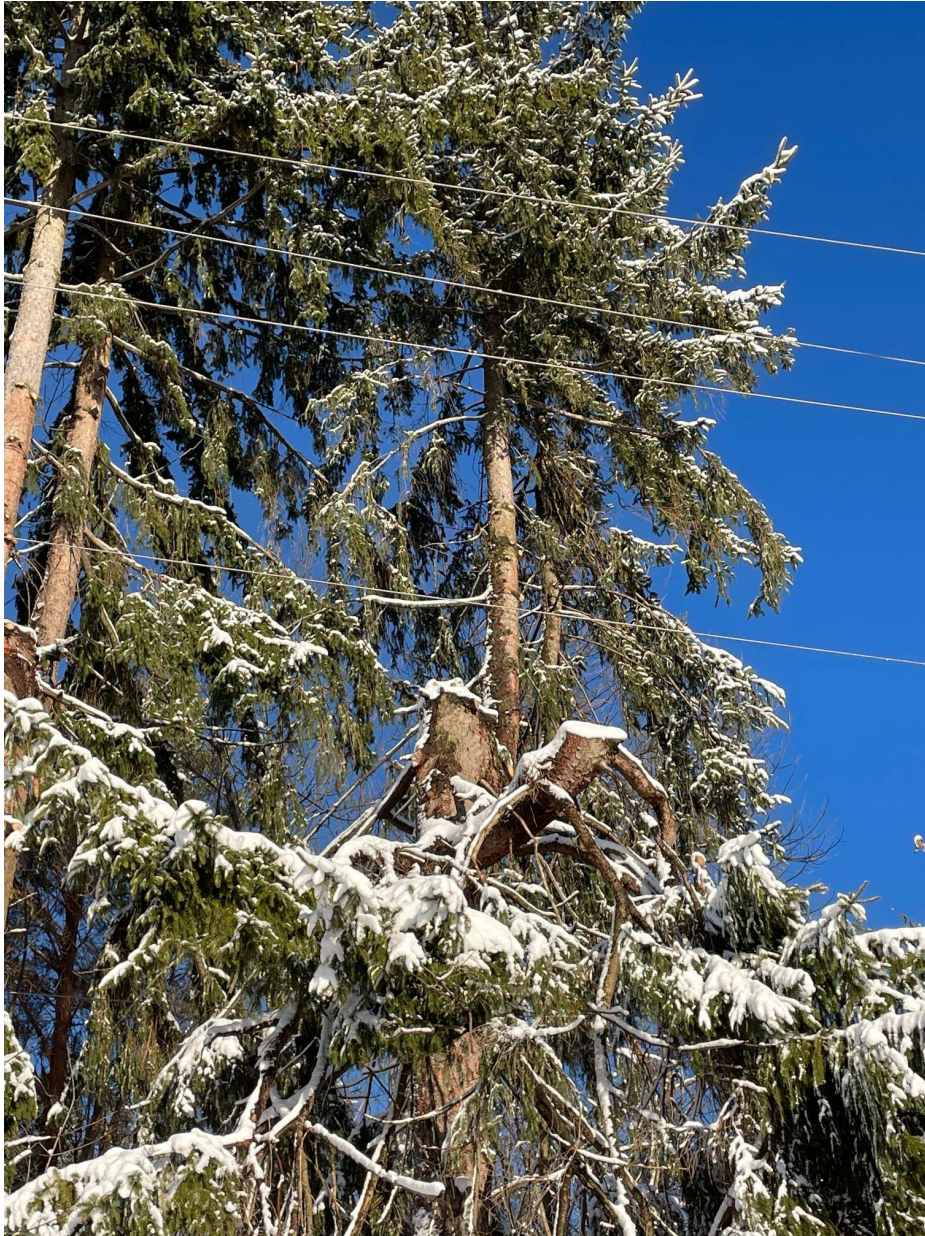
Picture 2: Large cuts of major limbs.

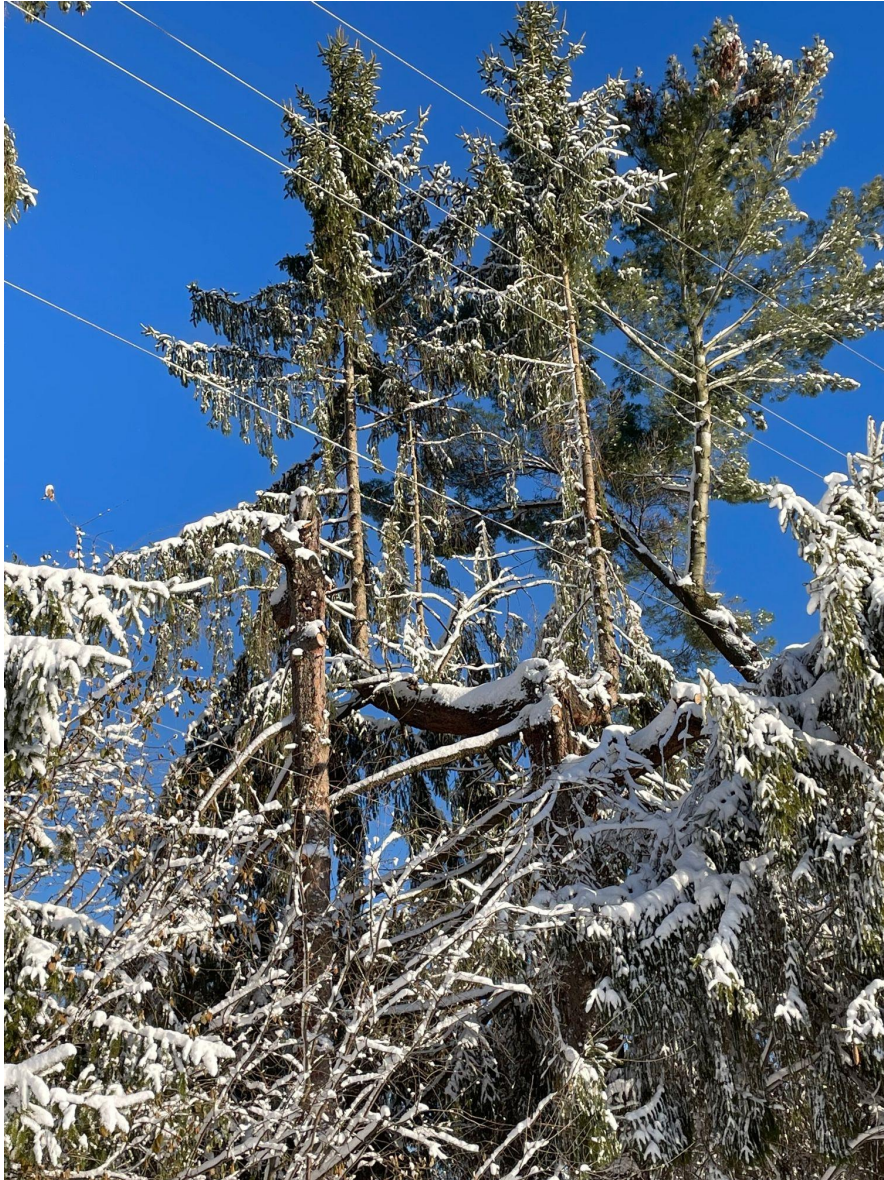
3. For some of the trees, past pruning has encouraged the trees to regrow branches on top. These new branches are often referred to as “sucker” growth. These branches are an emergency attempt by the tree to survive but the new limbs are weakly attached to the tree compared to regular branch attachment strength. All of the upright branches in picture 3 are examples of sucker growth.

Picture 3: Large “sucker” growth from old cuts. These limbs are weakly attached and unbalance the trees.
